Jonathan Cartwright

Service	Inspection Address	Inspector	Amount
Pre-Sale Home Inspec...	180 Wellington Way, Reno, NV 89506	Jonathan Cartwright	300.00

Client Information: Katherine Arriaga
Structure Type: Wood Frame
Foundation Type: Raised Foundation
Furnished: Yes
Number of Stories: One

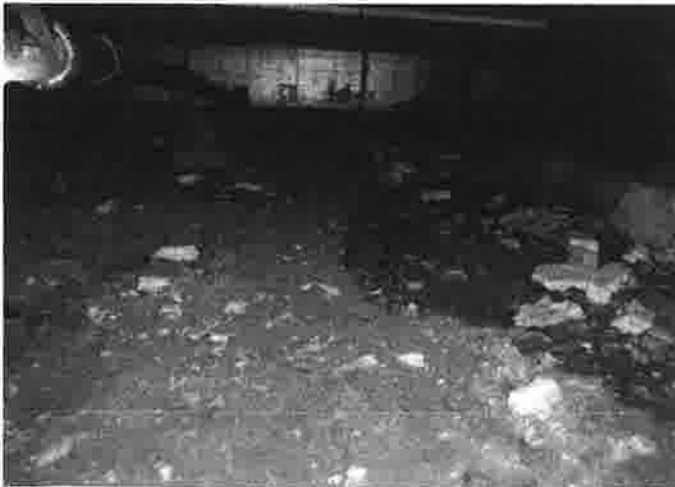
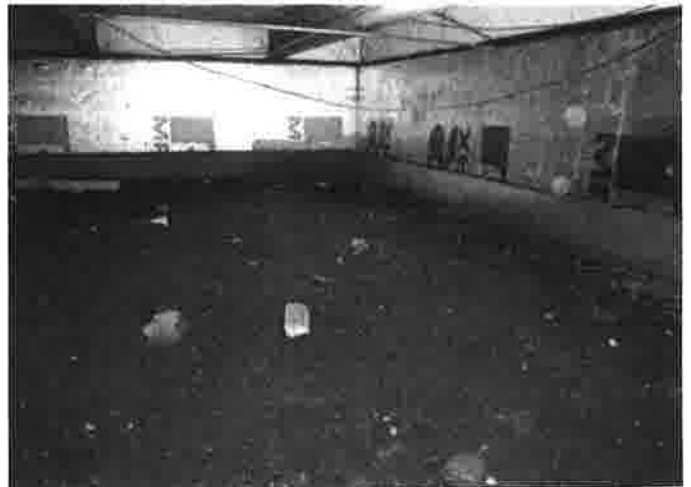
Recommend that a visqueen moisture barrier be placed to completely cover all soils to help control moisture in the crawlspace area. Any cellulose or other debris should be removed from the crawlspace before placing the moisture barrier.

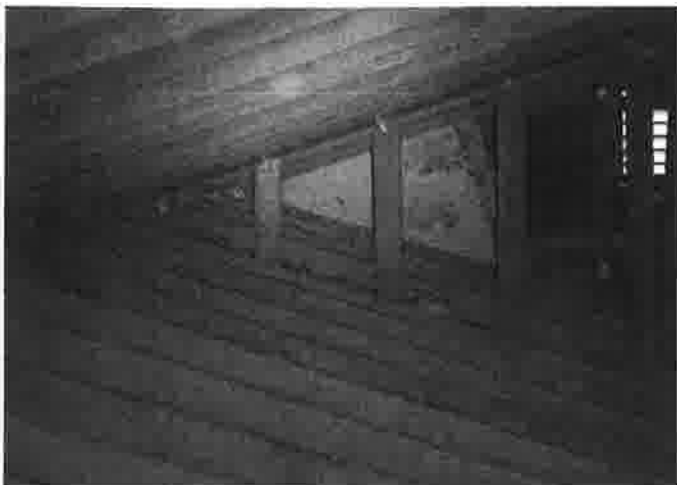
There was no insulation on the attic access cover or at the three skylights. Insulation should be installed for increased thermal efficiency.

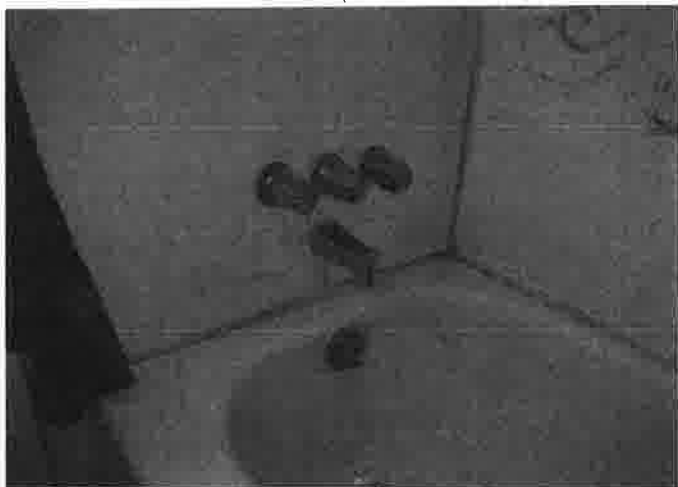
The hallway bathroom tub/shower hot and cold water faucet stems and the tub/shower diverter valve stem were leaking during operation.

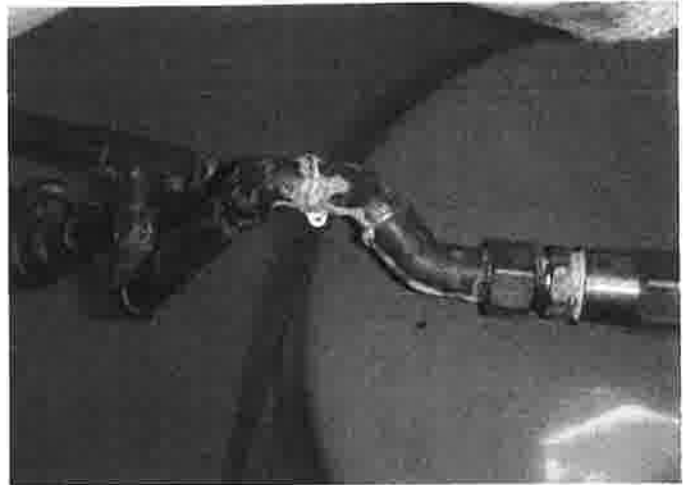
There was a leak in the copper supply line near the expansion tank on the boiler in the garage.

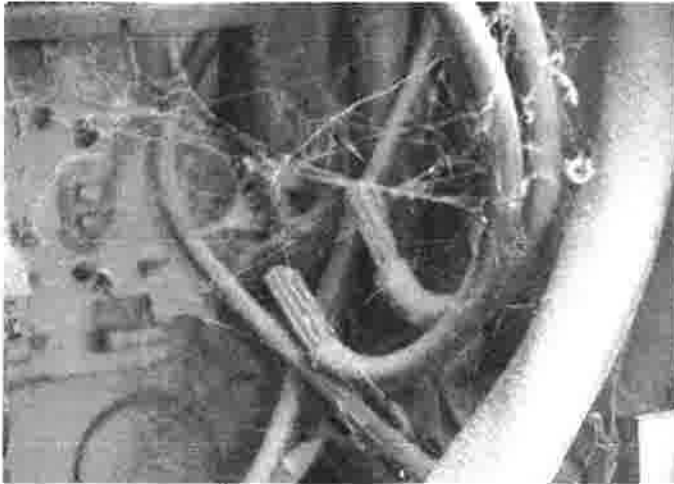
There were open ended wires observed in the main electrical service panel. These wires should be properly terminated or they should be removed.

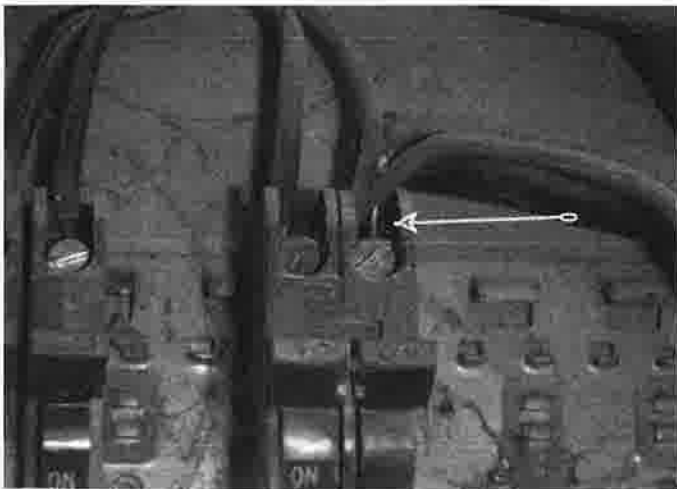
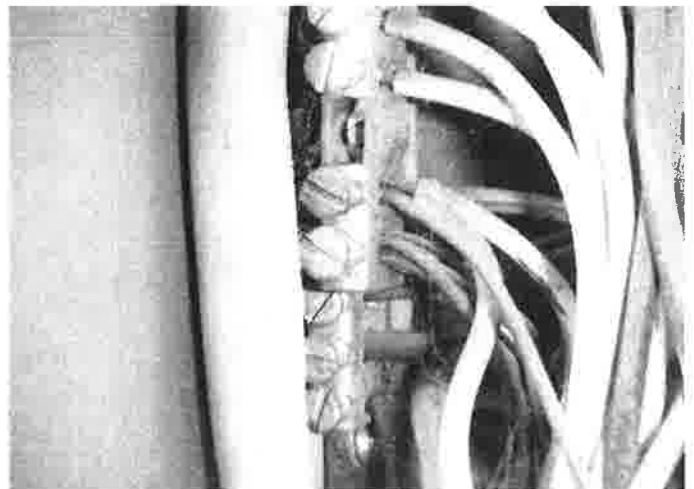
There was an electrical circuit breaker that had been wired incorrectly to two circuits. This condition was also observed at the neutral bus bar. This is commonly referred to as double-lugging and should be repaired by a licensed electrician.

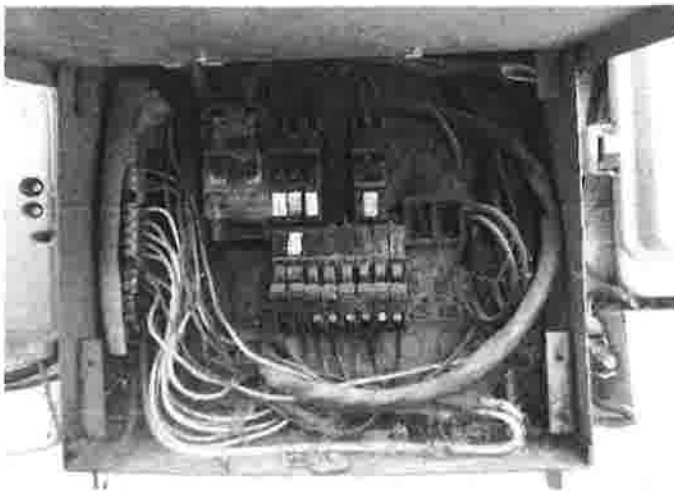
The interior cover panel, or dead-front, for the main electrical panel was missing, and should be replaced.

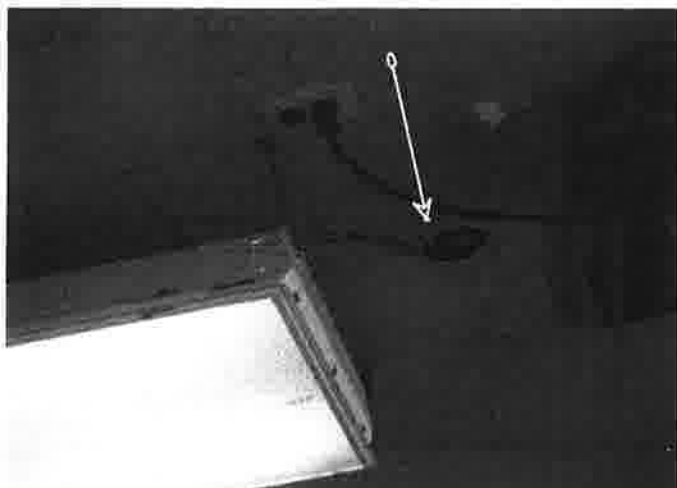
There was an open wire splice and exposed wiring on the garage ceiling. The splice should be made up within a junction box and properly covered. Any left over wiring that is exposed should be enclosed within the fixture it served or protected in conduit.

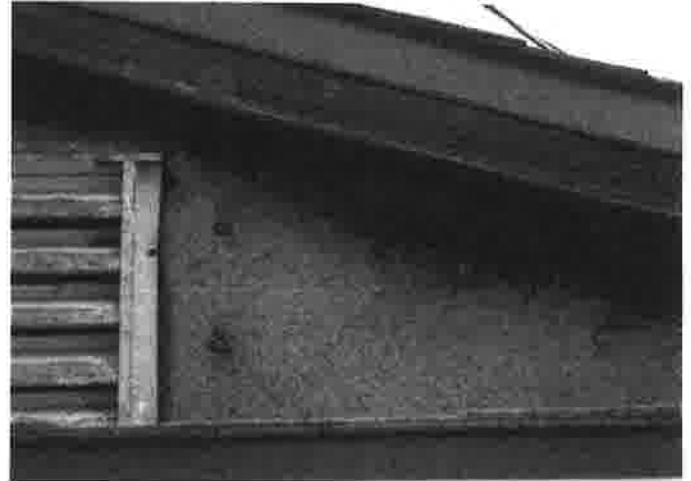
The hardboard type siding, at the south gable area, was unpainted and moisture affected. This siding should be refinished to help prevent further damage. This gable was not fully visible due to snow conditions and additional faults may exist.

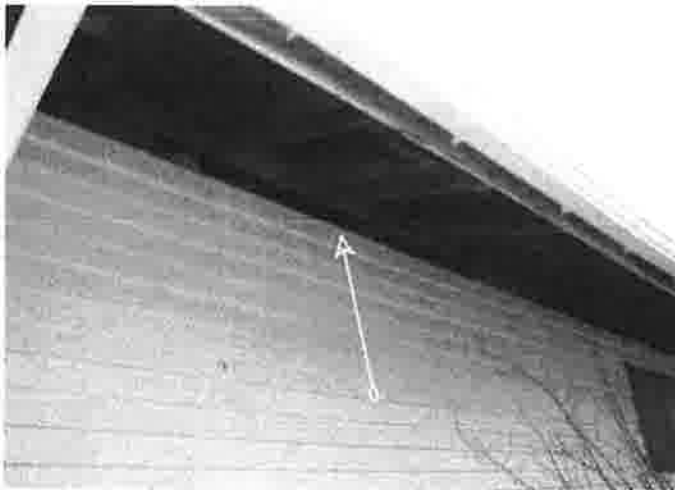
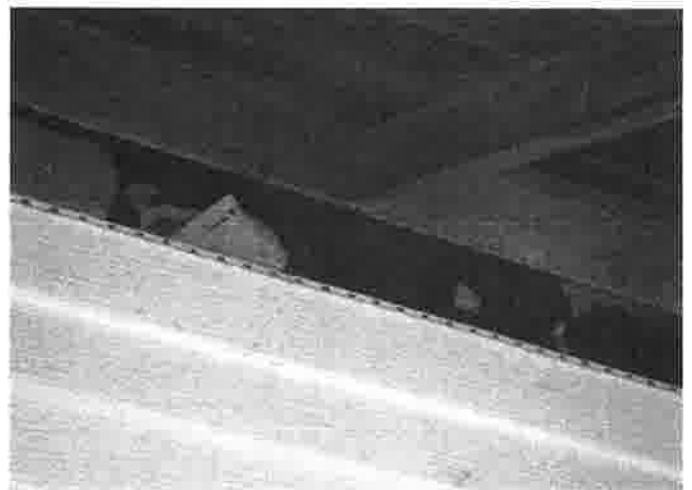
There were several areas around the perimeter, at the top edges of the siding, where there were missing sections of the siding. Multiple areas of the perimeter siding needed to be prepped and painted.

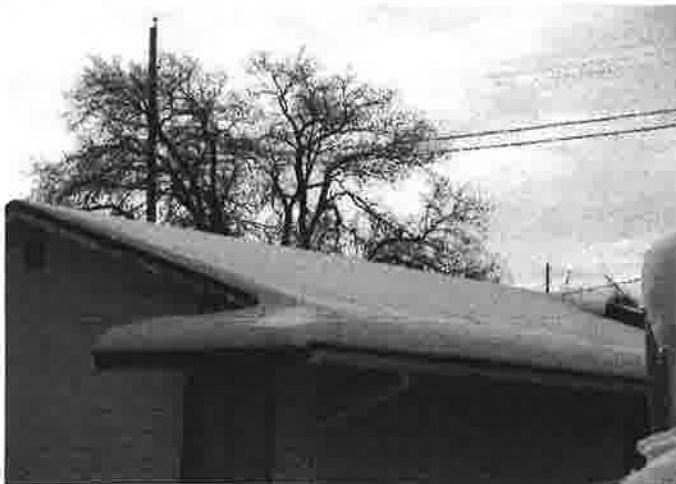
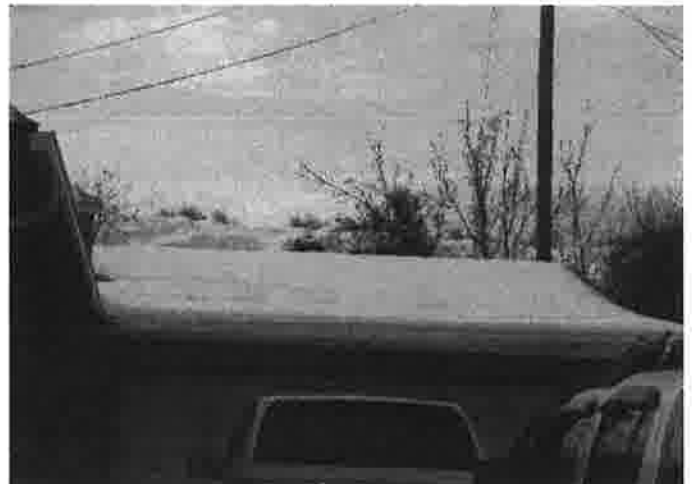
Snow conditions prevented review of the roof cover, and it was evaluated from within the attic and from available vantage points on the ground. The roof should be professionally assessed when fully accessible.

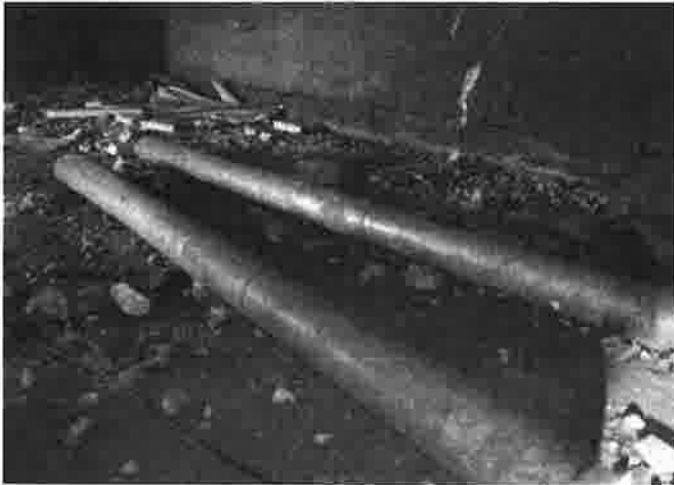
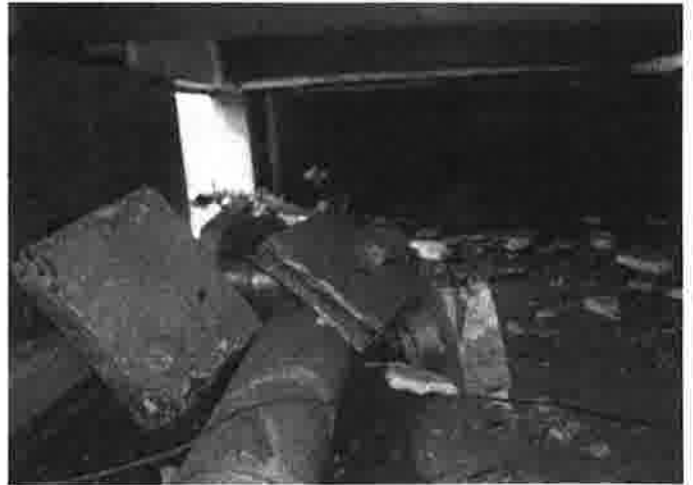
It is recommended that all cellulose and other debris be removed from the crawlspace.

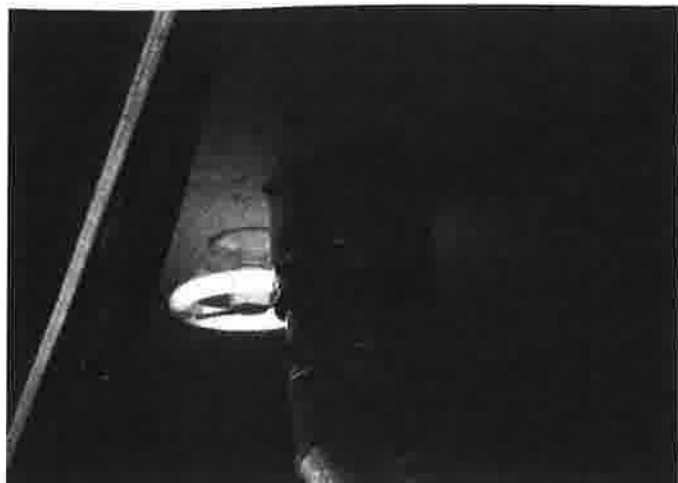
There were moisture stains on the ceiling of the garage around the boiler flue pipe penetration that appeared to be from a past or present roof leak. It was not possible to determine if the roof was currently leaking and all stained areas appeared dry at the time of this inspection. Consult with the seller for additional information and have the roof serviced as needed.

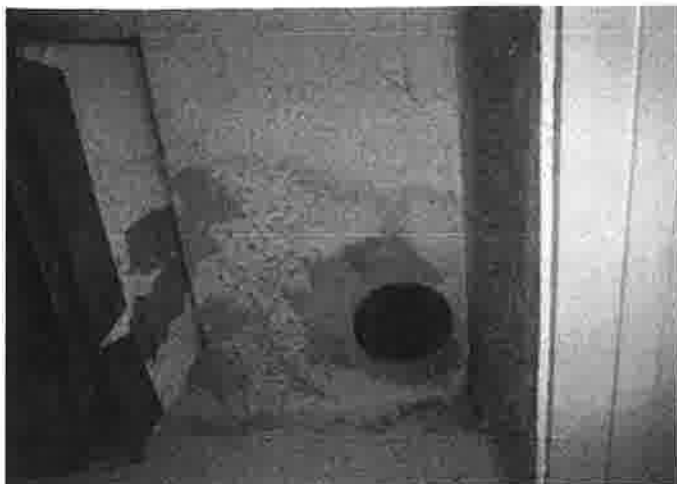
There were holes in the ceiling of the hallway northwest closet where it appeared that the furnace had been previously located. These openings should be repaired to help limit conditioned air losses from the interior and to help prevent attic insulation from falling into the interior.

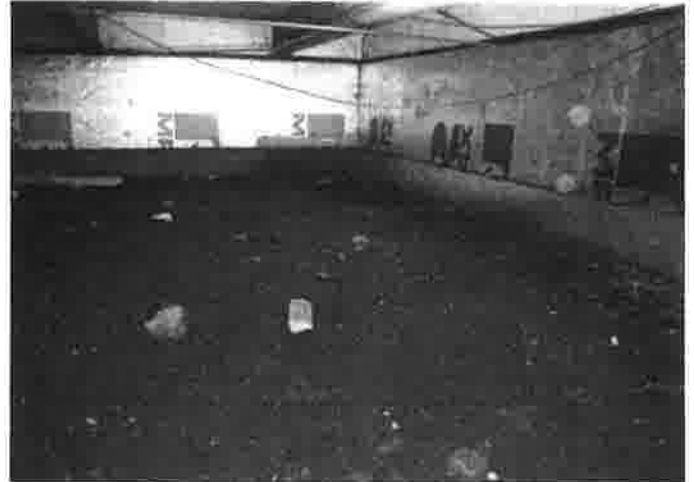
- Recommend that a visqueen moisture barrier be placed to completely cover all soils to help control moisture in the crawlspace area. Any cellulose or other debris should be removed from the crawlspace before placing the moisture barrier.

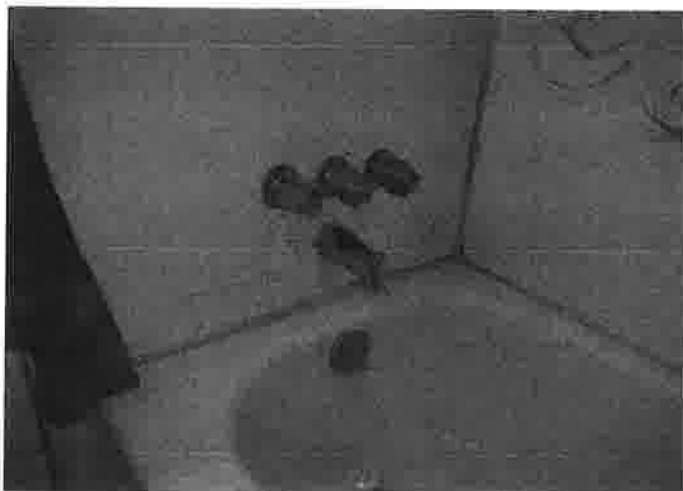
- The hallway bathroom tub/shower hot and cold water faucet stems and the tub/shower diverter valve stem were leaking during operation.

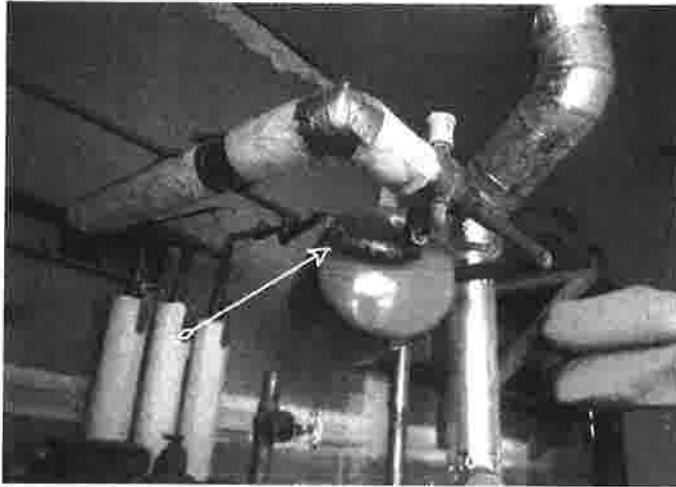
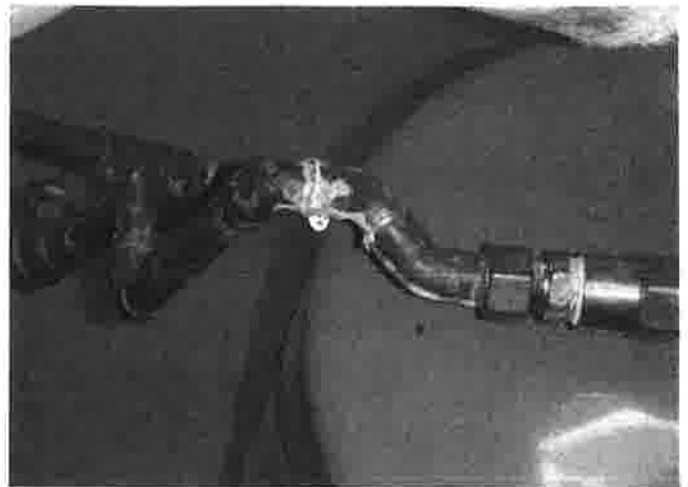
- There was a leak in the copper supply line near the expansion tank on the boiler in the garage.

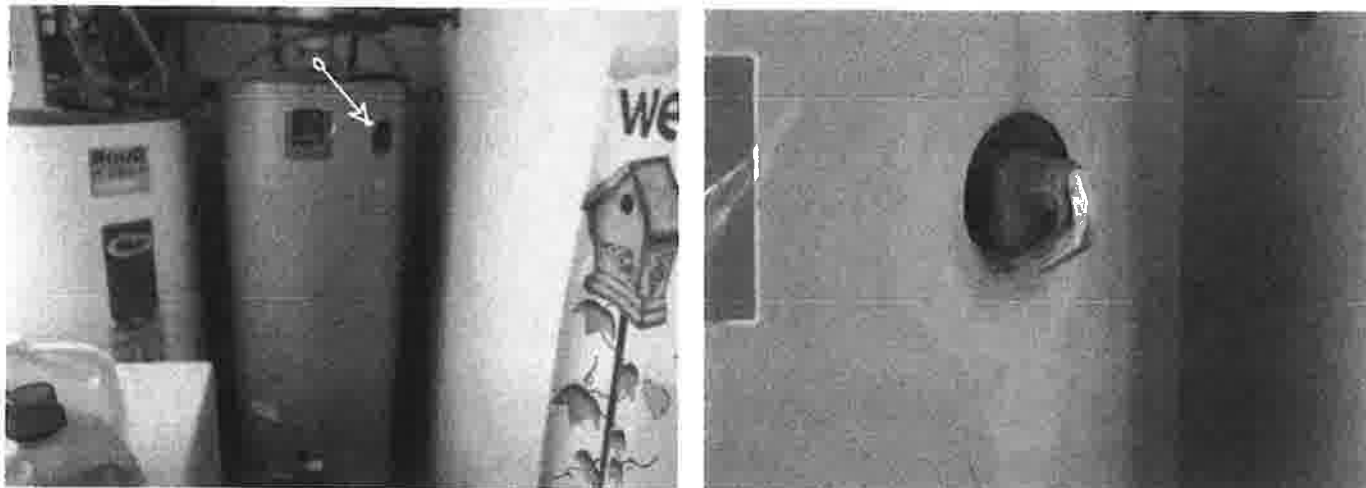
- The temperature/pressure relief valve on the water heater did not have a discharge pipe. A proper drain line that extends to the exterior should be installed.

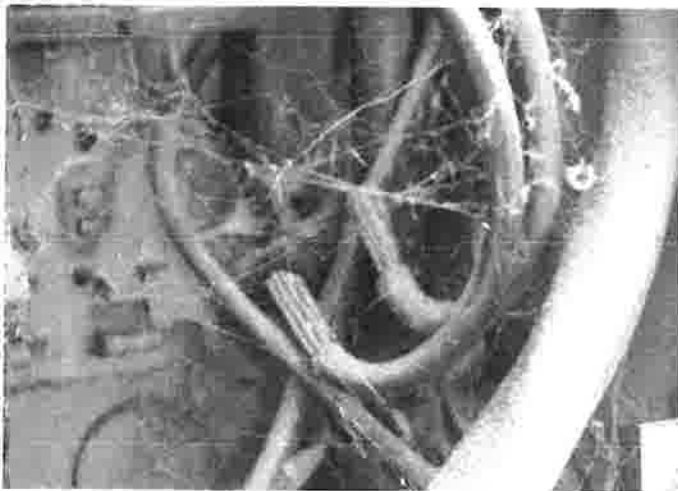
- There were open ended wires observed in the main electrical service panel. These wires should be properly terminated or they should be removed.

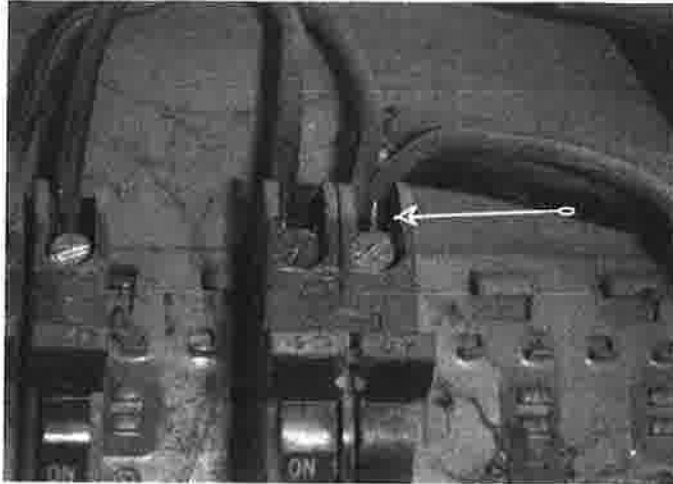
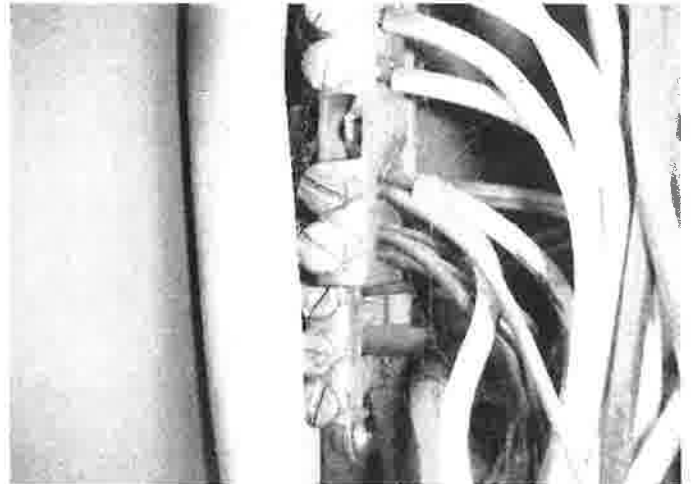
- There was an electrical circuit breaker that had been wired incorrectly to two circuits. This condition was also observed at the neutral bus bar. This is commonly referred to as double-lugging and should be repaired by a licensed electrician.

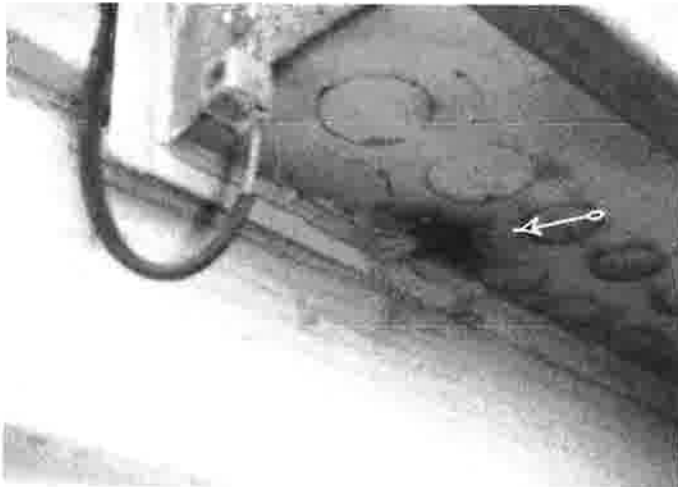
- There was an open knock-out in the bottom of the main electrical service panel box that should be properly covered.

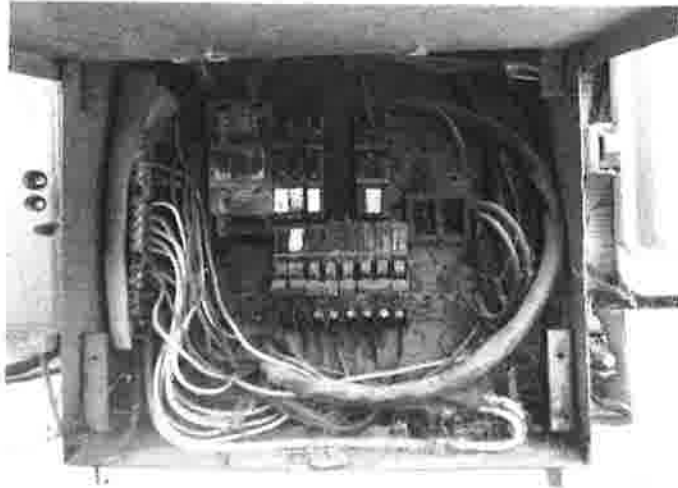
- The interior cover panel, or dead-front, for the main electrical panel was missing, and should be replaced.

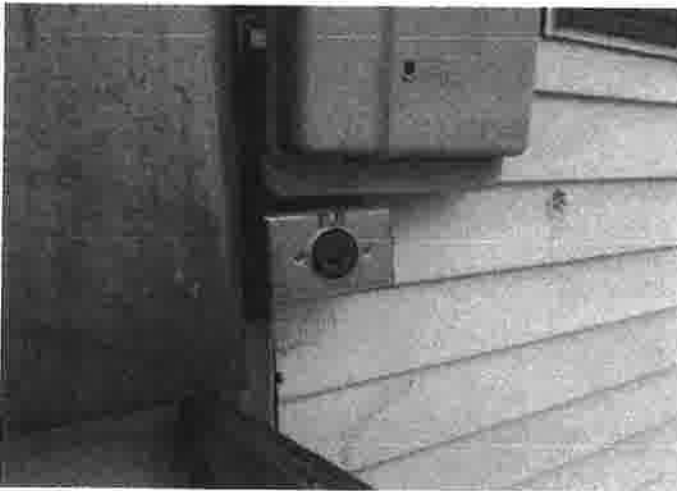
- The east exterior outlet, by the main service panel, had a damaged weather proof cover that should be replaced.

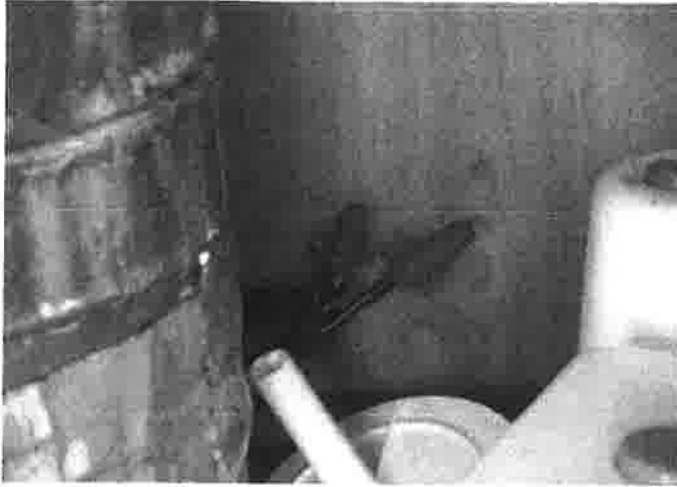
- The cord for the food waste disposer was loose. This cord should be secured to the disposer case using a proper grommet to help prevent accidental separation of the cord from the appliance.
- There was an open/exposed wire splice in the cabinet above the kitchen range. All splices should be made up in junction boxes and properly covered.

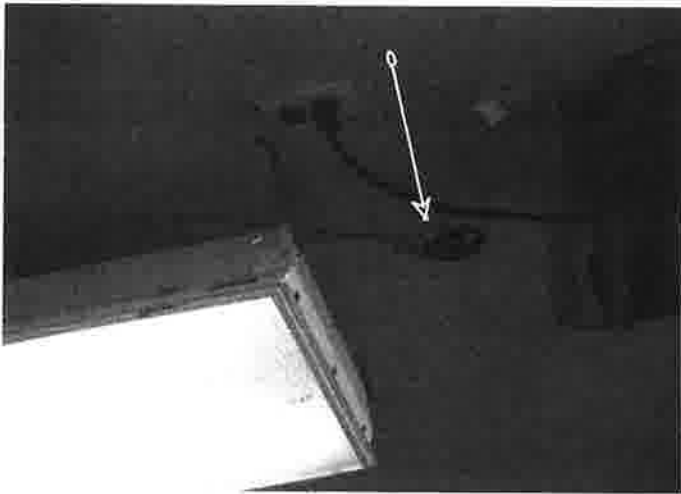
- There was an open wire splice and exposed wiring on the garage ceiling. The splice should be made up within a junction box and properly covered. Any left over wiring that is exposed should be enclosed within the fixture it served or protected in conduit.

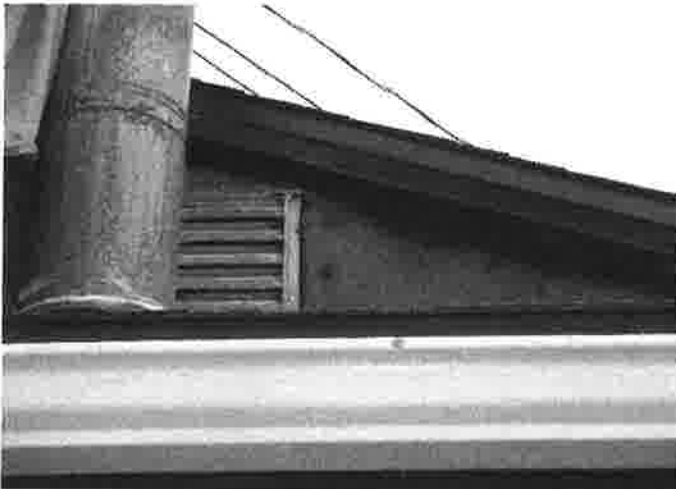
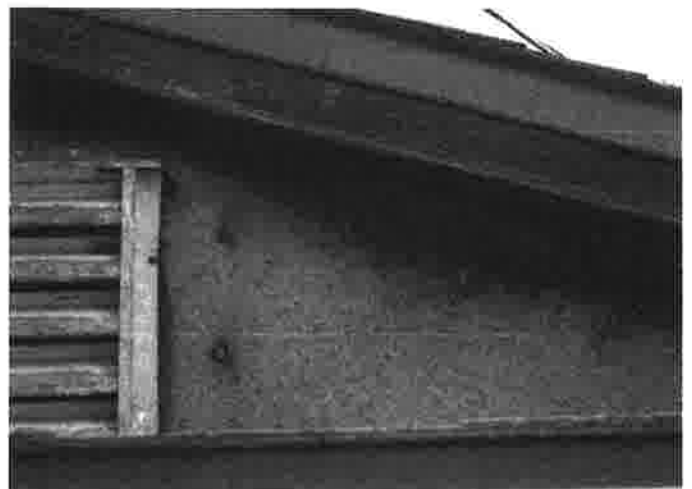
- The hardboard type siding, at the south gable area, was unpainted and moisture affected. This siding should be refinished to help prevent further damage. This gable was not fully visible due to snow conditions and additional faults may exist.

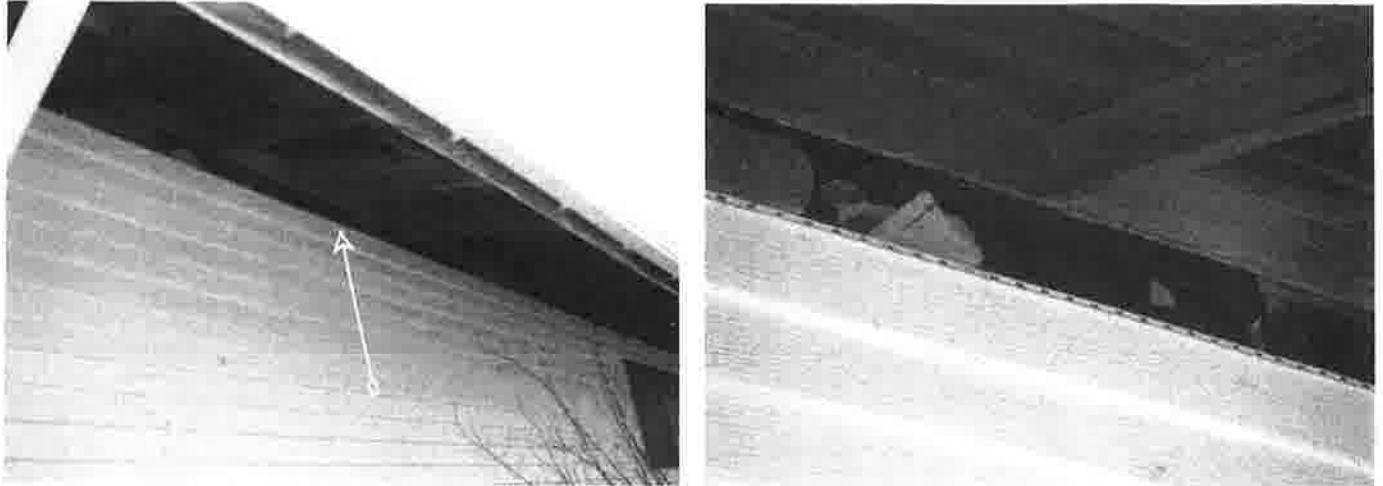
- There were several areas around the perimeter, at the top edges of the siding, where there were missing sections of the siding. Multiple areas of the perimeter siding needed to be prepped and painted.

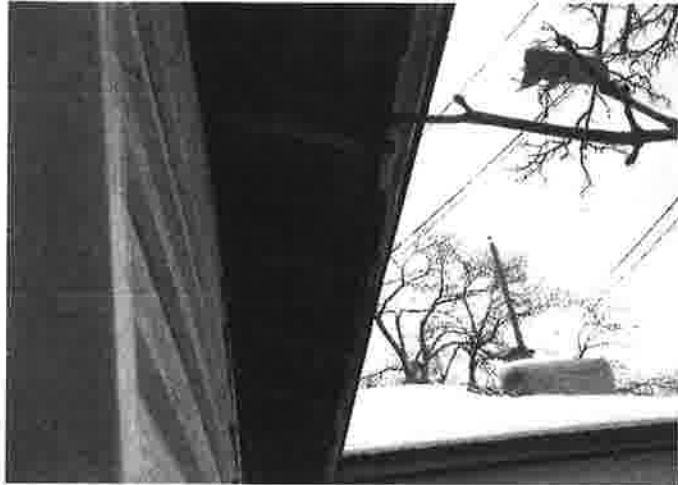
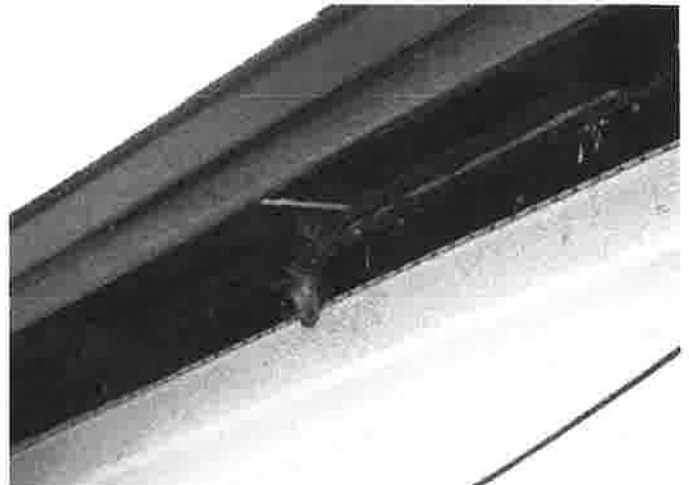
- There were several areas of water stained roof sheeting at the perimeter eave. The eaves should be kept well maintained and painted to help prevent damage. There were gaps at the southwest soffit adjacent to the family room where it appeared that birds may have penetrated into the attic space. These gaps should be properly covered to help prevent bird intrusions.

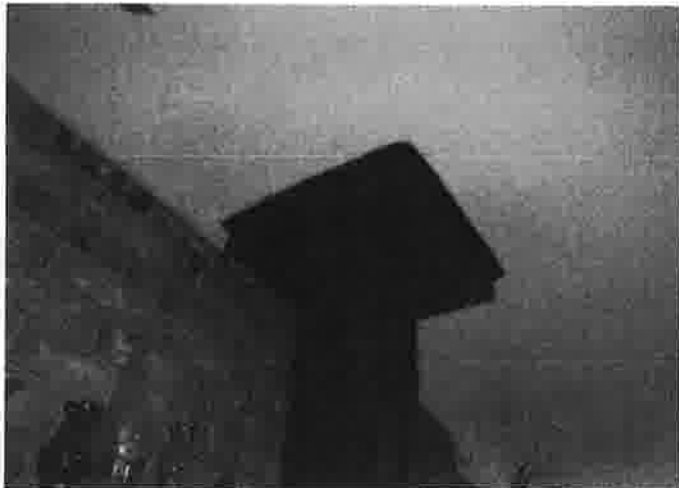
- The top cap for the wood stove flue was missing and a new cap should be installed. This condition may have caused or contributed to the water staining and rust observed on the flue at the interior of the family room.

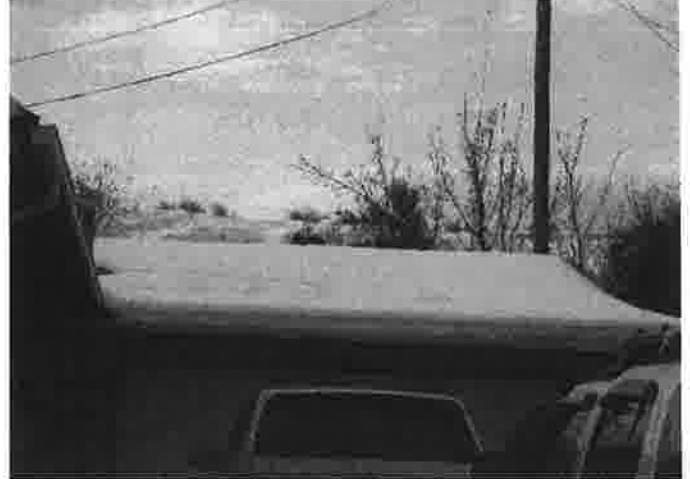
- Snow conditions prevented review of the roof cover, and it was evaluated from within the attic and from available vantage points on the ground. The roof should be professionally assessed when fully accessible.

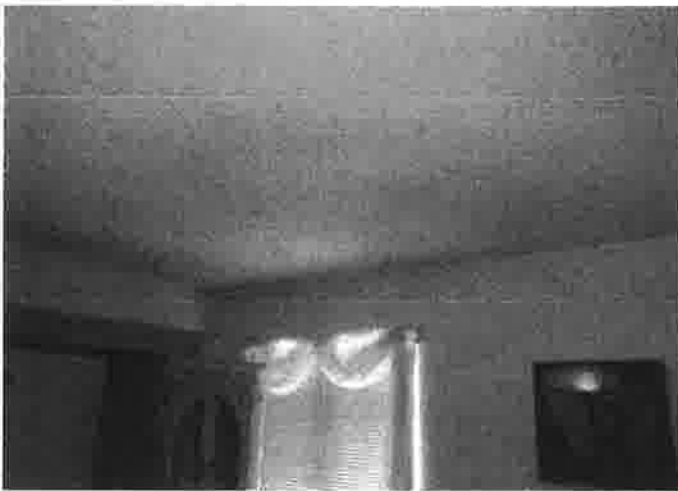
- There were moisture stains/surface damage on the ceiling that appeared to be the result of a prior roof leak. It was not determined to what extent repairs had been made or the cause or extent of the original damage. The ceiling surfaces had since been painted. The condition should be further investigated and/or explained by the seller.

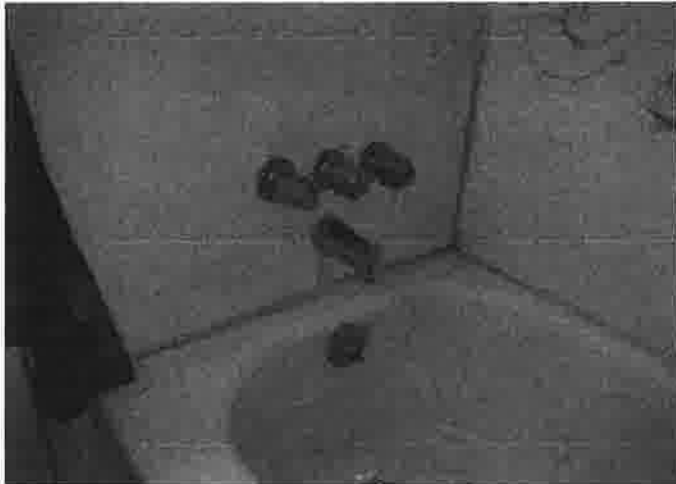
- There were loose surround panels in the tub/shower area. Some of the hardboard type panels were surface damaged. This area should be evaluated for repair and to determine if moisture damage had resulted behind the surround.
