Jonathan Cartwright

Service	Inspection Address	Inspector	Amount
Pre-Sale Home Inspec...	180 Wellington Way, Reno, NV 89506	Jonathan Cartwright	300.00

Client Information: Katherine Arriaga
Structure Type: Wood Frame
Foundation Type: Raised Foundation
Furnished: Yes
Number of Stories: One

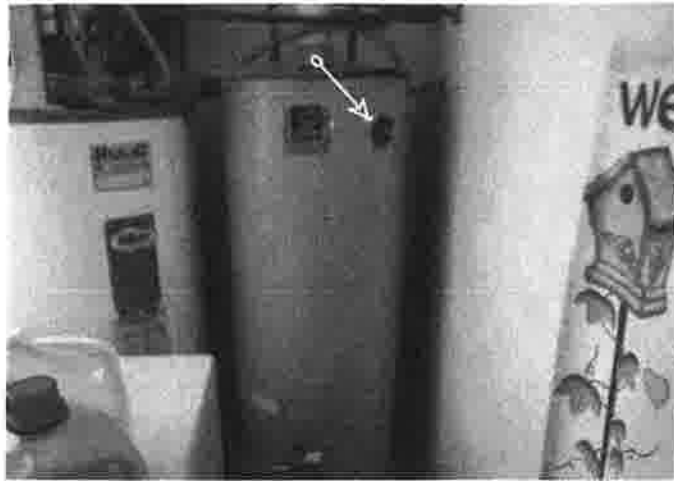
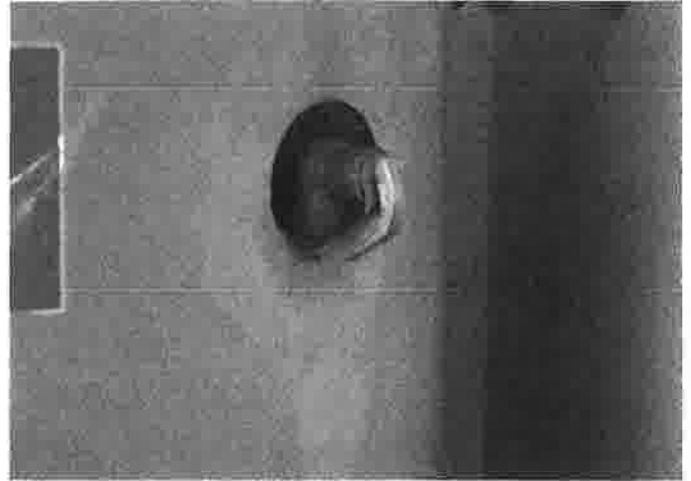
The large expansion tank, above the gas boiler, was supported only by the plumbing. Properly strapping this tank to wall or ceiling framing can help relieve stress on the adjacent plumbing connections which could lead to damage and leaks.

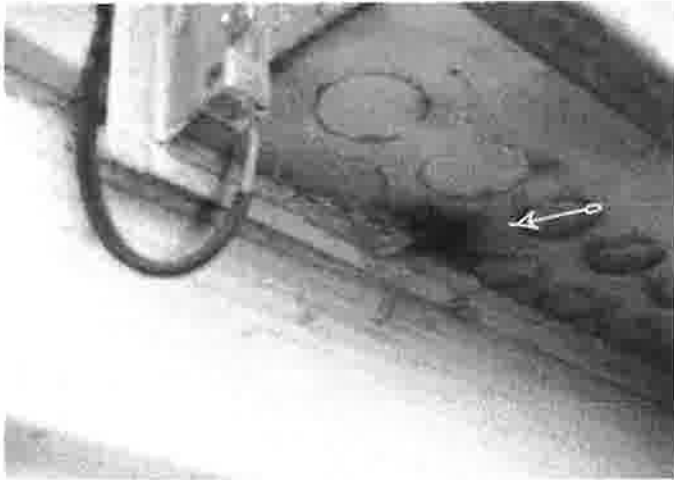
There was an open knock-out in the bottom of the main electrical service panel box that should be properly covered.

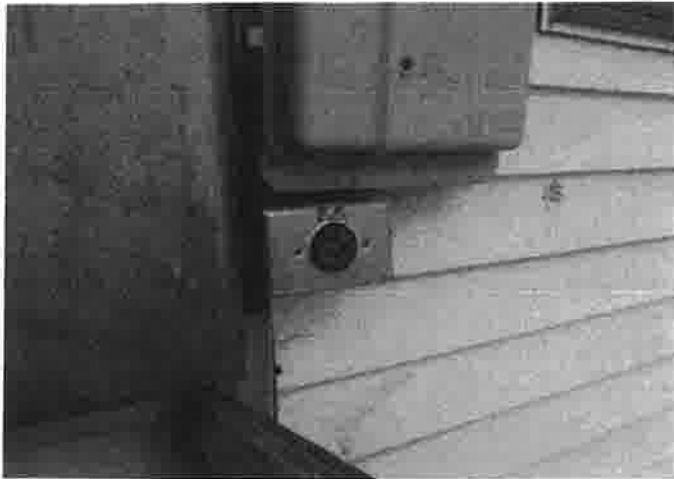
The east exterior outlet, by the main service panel, had a damaged weather proof cover that should be replaced.

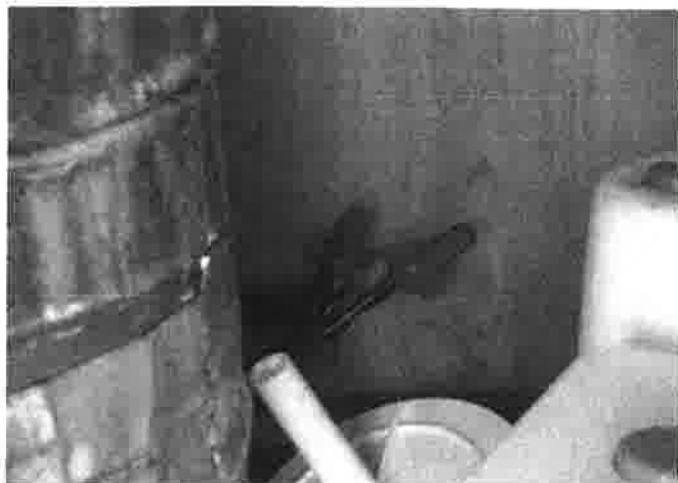
There was an open/exposed wire splice in the cabinet above the kitchen range. All splices should be made up in junction boxes and properly covered.

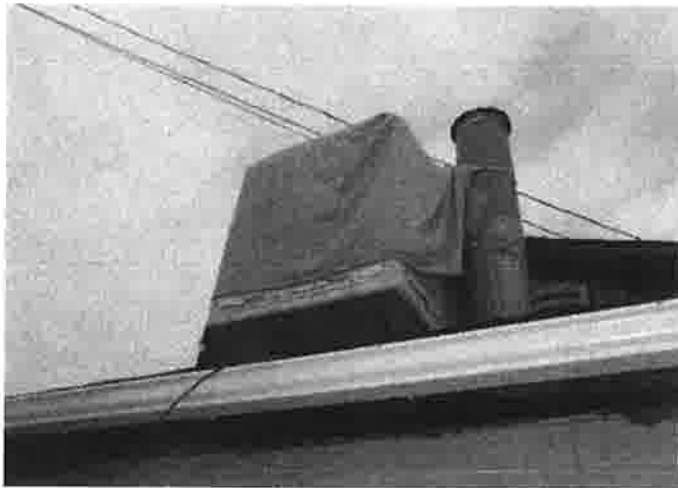
Swamp coolers were not operated or evaluated for this inspection. This cooler was covered and presumed to have been winterized.

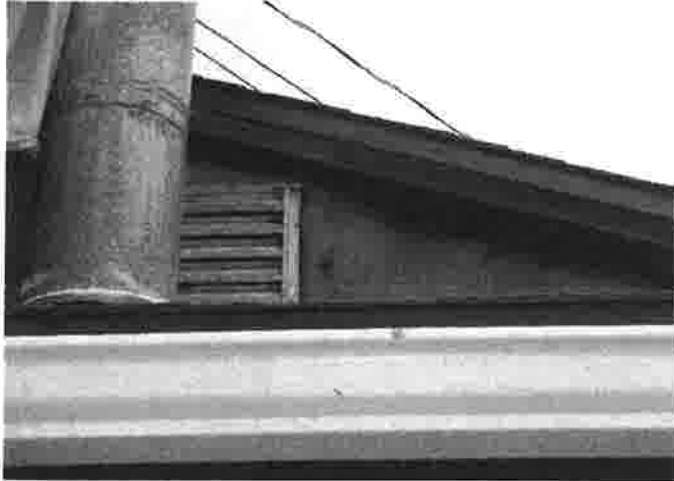
The hardboard type siding, at the south gable area, was unpainted and moisture affected. This siding should be refinished to help prevent further damage. This gable was not fully visible due to snow conditions and additional faults may exist.

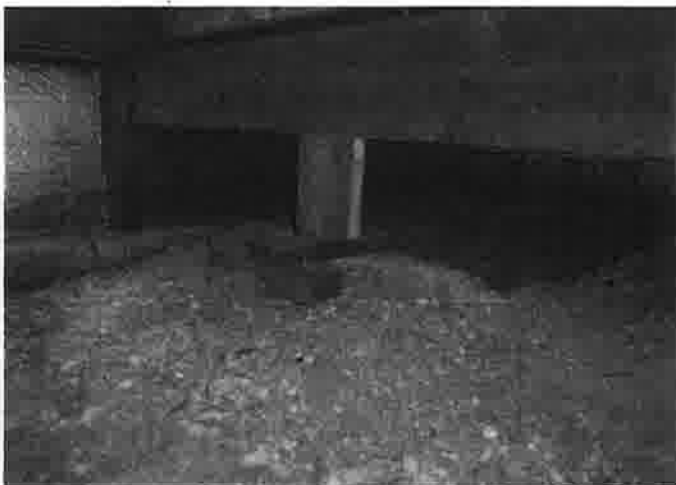
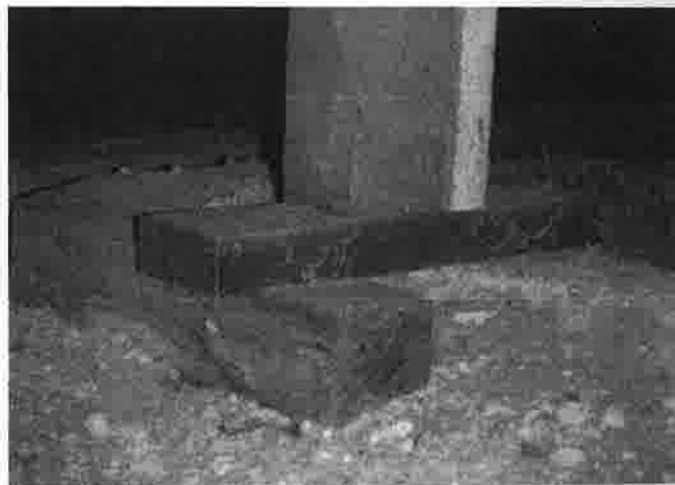
Recommend that soils be moved away from any posts that contact the dirt or that the posts be reset above the soils on concrete piers.

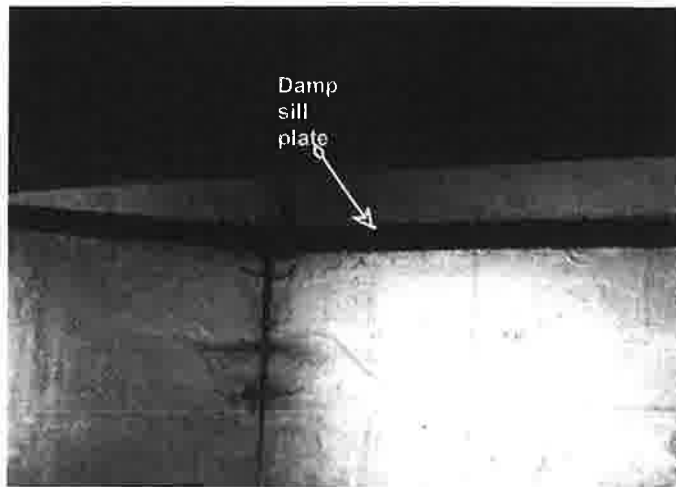
There was fungi growth on the subfloor at the front/northwest area of the crawlspace where damp soils and marginal ventilation had allowed for a very humid condition. The perimeter rim joist was insulated with rigid foam and while the small areas of exposed rim joist appeared dry some areas of the north and northwest wood sill plate, on top of the foundation wall, were damp. The crawlspace should have a moisture barrier installed and the infected wood surfaces should be treated using a registered fungicide applied by a state licensed pest management professional. Details of any wood destroying pest treatment should be recorded on form DA-PD 2 Wood Destroying Pests Inspection Report as required by the Nevada Department of Agriculture.

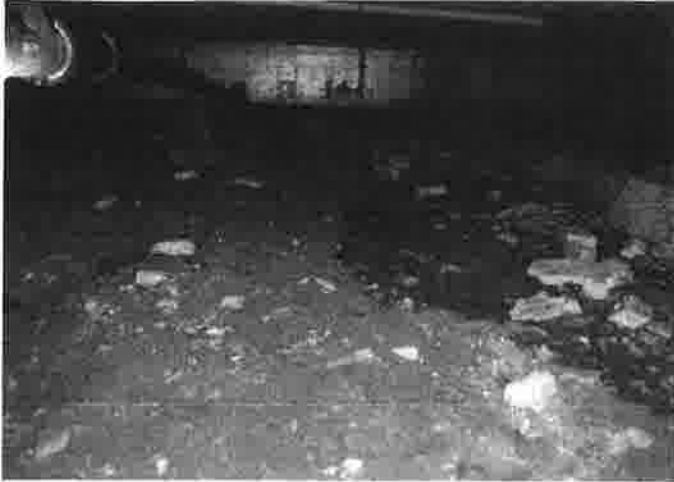
- Recommend that a visqueen moisture barrier be placed to completely cover all soils to help control moisture in the crawlspace area. Any cellulose or other debris should be removed from the crawlspace before placing the moisture barrier.

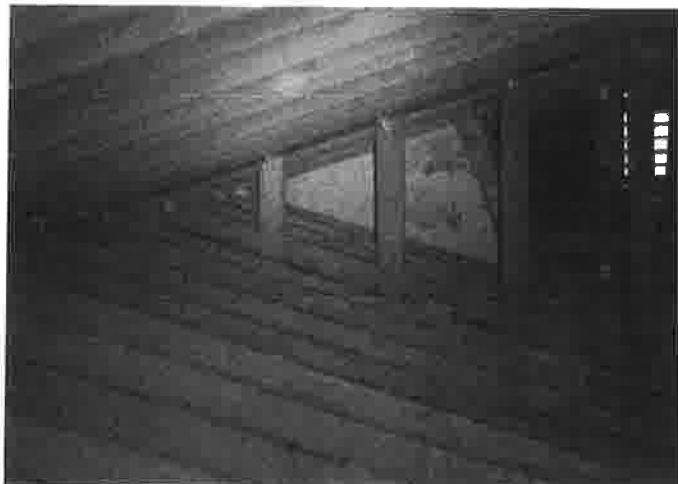
- There was no insulation on the attic access cover or at the three skylights. Insulation should be installed for increased thermal efficiency.

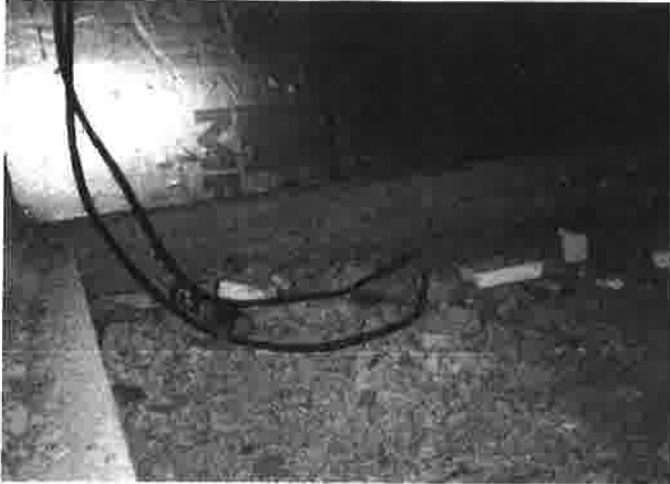
- There were open ended wires in the northeast area of the rear addition crawlspace that should be properly terminated in a covered junction box or they should be removed.

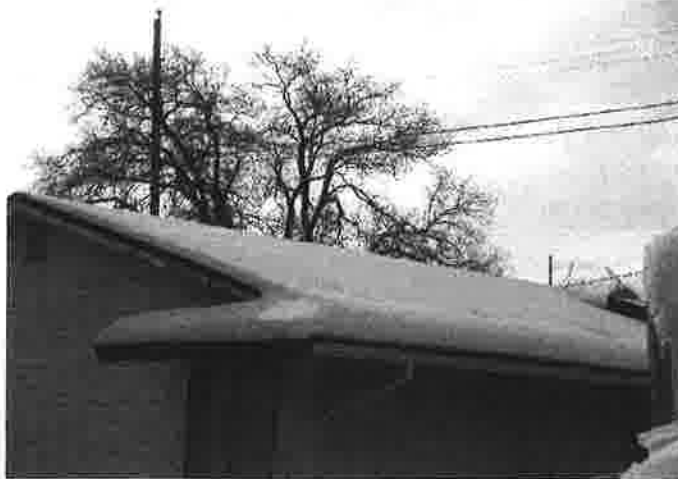
- Snow conditions prevented review of the roof cover, and it was evaluated from within the attic and from available vantage points on the ground. The roof should be professionally assessed when fully accessible.

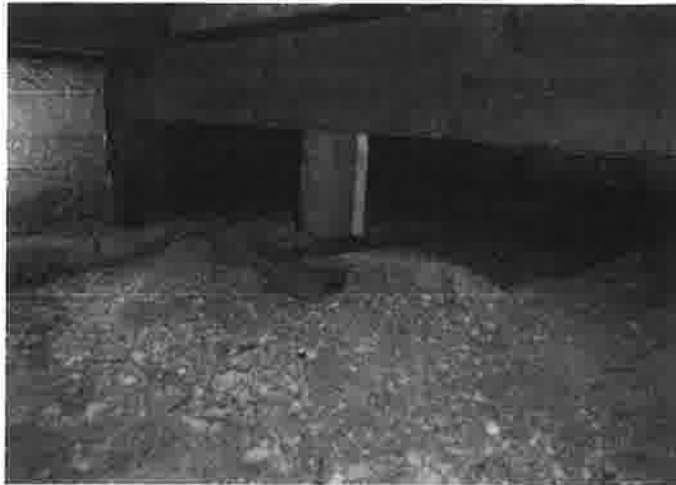
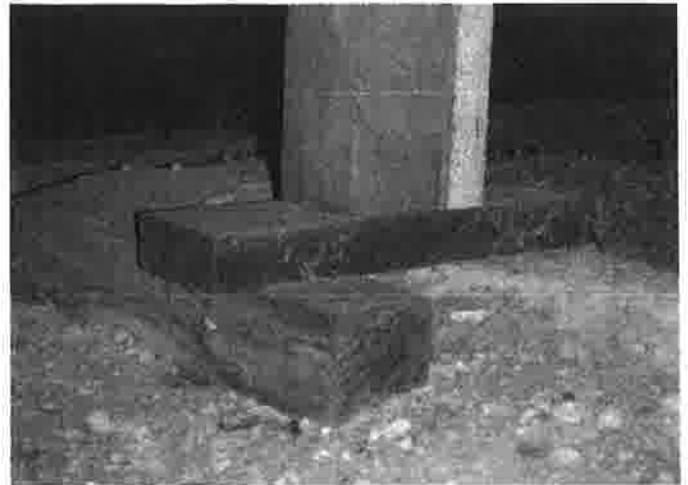
- There was fungi growth on the subfloor at the front/northwest area of the crawlspace where damp soils and marginal ventilation had allowed for a very humid condition. The perimeter rim joist was insulated with rigid foam and while the small areas of exposed rim joist appeared dry some areas of the north and northwest wood sill plate, on top of the foundation wall, were damp. The crawlspace should have a moisture barrier installed and the infected wood surfaces should be treated using a registered fungicide applied by a state licensed pest management professional. Details of any wood destroying pest treatment should be recorded on form DA-PD 2 Wood Destroying Pests Inspection Report as required by the Nevada Department of Agriculture.

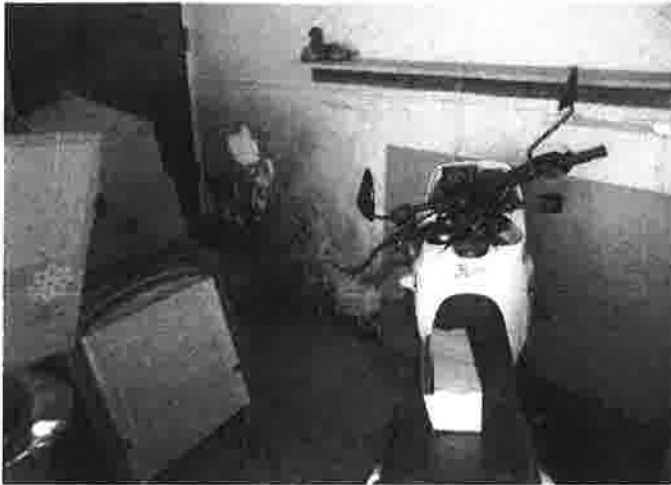
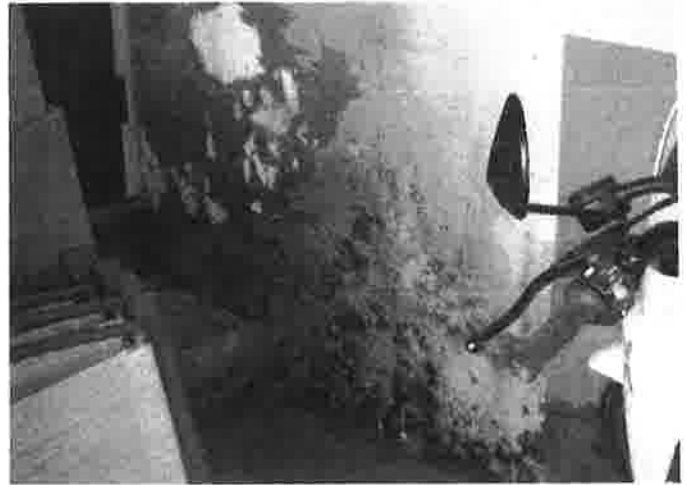
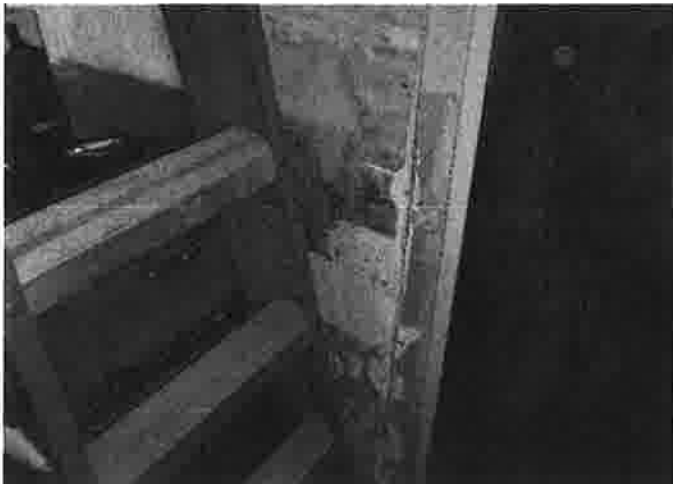
- There were moisture stains and discoloration on the sheetrock wall surfaces around the house entry door and the laundry room. The exact cause of this condition was unknown. It was not possible to determine if there were current leaks/moisture conditions and all stained areas appeared dry at the time of this inspection. Consult with the seller for additional information and have these wall areas serviced as needed.

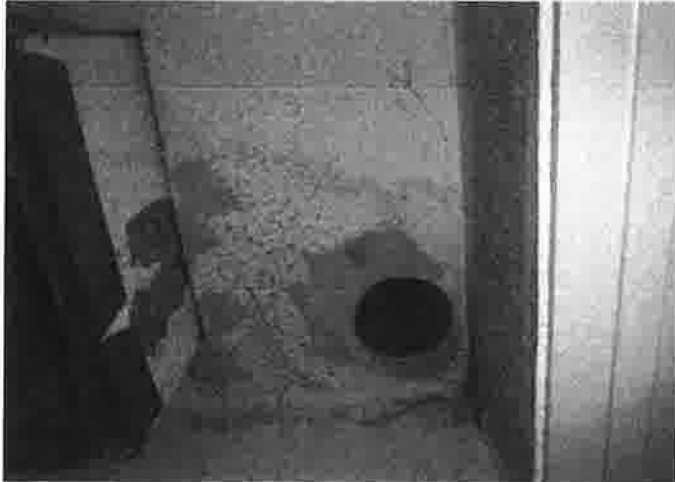
- There were holes in the ceiling of the hallway northwest closet where it appeared that the furnace had been previously located. These openings should be repaired to help limit conditioned air losses from the interior and to help prevent attic insulation from falling into the interior.
